# VEHICLE INSPECTION REPORT

**HX17NTY**

## Daf CF 460

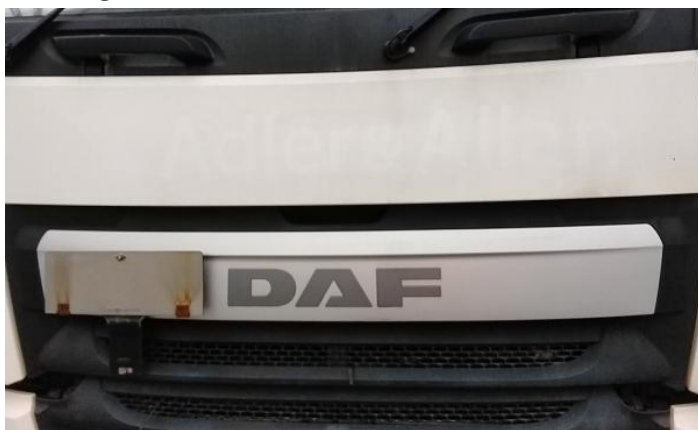
1: Bonnet  
Chipped  
Multiple Chips

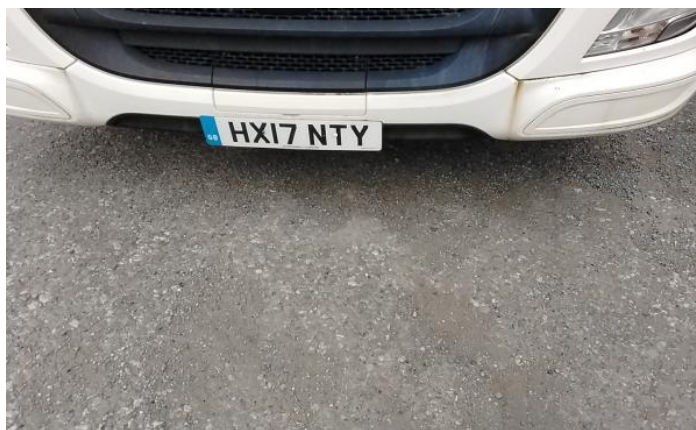
2: Bumper Front  
Chipped  
Multiple Chips

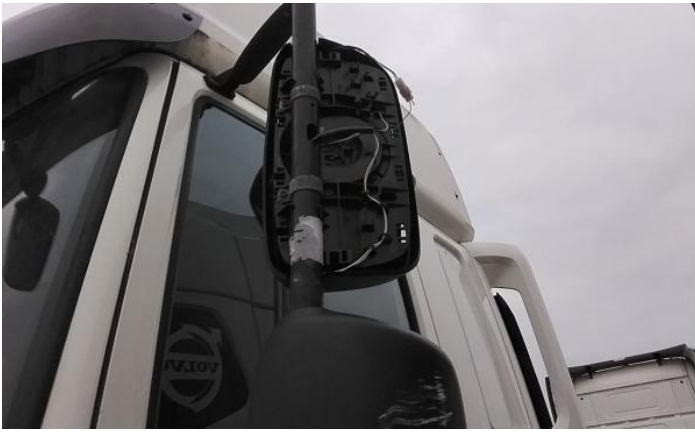
3: Door Mirror Assy nsf  
Broken  
Replace

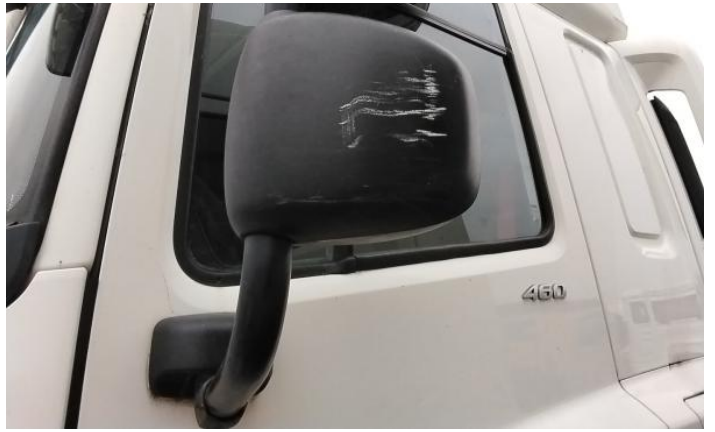
4: Door Mirror Assy nsf  
Scuffed (Unpainted)  
UpTo 100mm

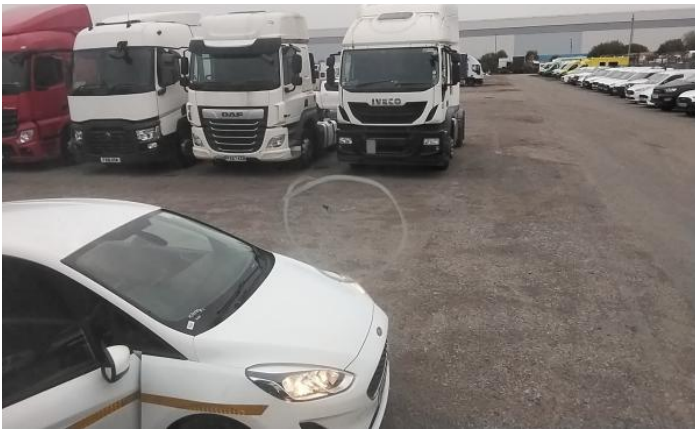
5: Screen Front  
Chipped  
Over 10mm

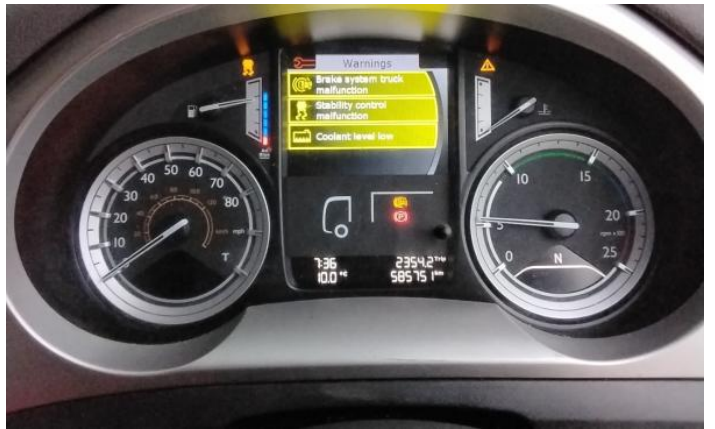
6: Dash Warning Lights  
Displayed  
No Action
