VEHICLE INSPECTION REPORT

PN24JTZ

Renault Master 35 2.3

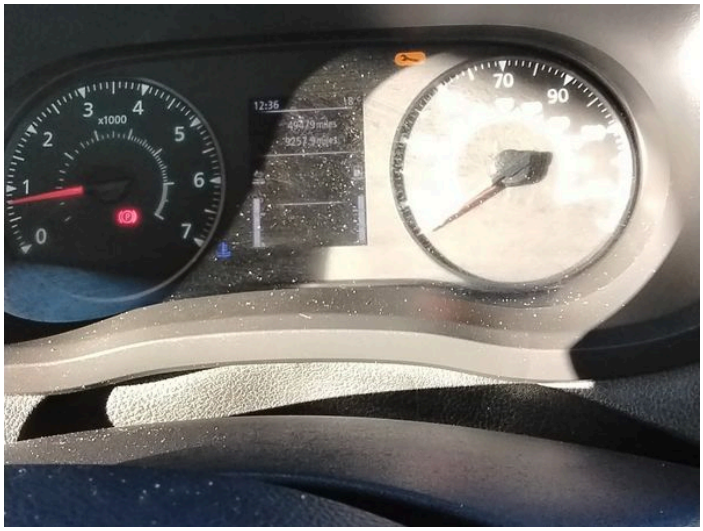
1: Bumper Front
Scratched
Over 100mm Thru Paint

2: Door Mirror Assy nsf
Scuffed (Unpainted)
Over 100mm

3: Door nsf
Scratched
Over 25mm Thru Paint

4: Sill ns
Dented
With Paint Damage

5: B Post ns
Chipped
Multiple Chips

6: B Post os
Scratched
Over 25mm Thru Paint

7: Door osf
Scratched
Over 25mm Thru Paint

8: Door Moulding osf
Scuffed (Unpainted)
Over 100mm

9: Dash Warning Lights
Displayed
No Action
